## Thermal opportunities in the grocery store market

### Application Note

#### Field Applications Case Study

**Inspection points:** Compressors, roof, refrigerant tubes, freezer doors, light ballasts, and electrical circuits.

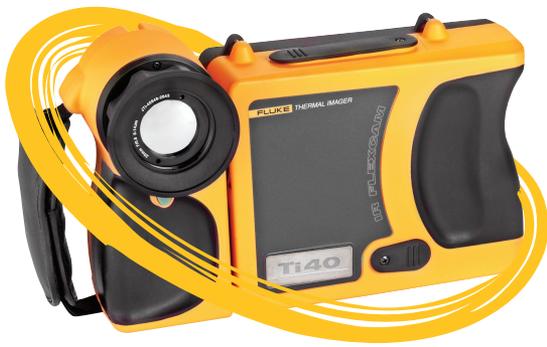
One store saved an estimated \$20,000 after an infrared scan identified a compressor that was 70° F hotter than similar units in the room. This compressor would have failed if the hot spot hadn't been identified.

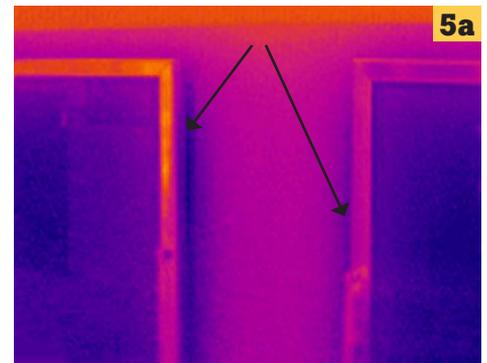
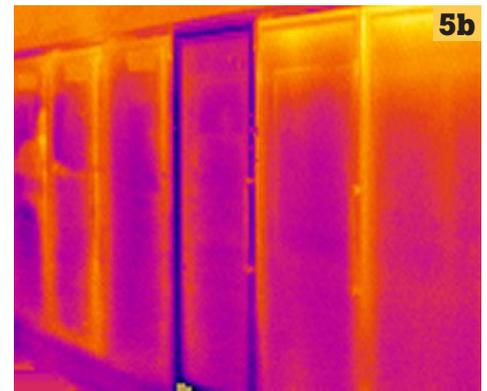
The frozen food aisle has two general categories of units: The upright closet “glass door” style and the open chest type, often referred to as the “bunker” freezer. The glass door freezers often have highly reflective aluminum door frames with glass inserts. The door frames contain heating elements to help prevent frost build up and rubber seals to help prevent cold air loss while the door is closed. Finding cold air loss is a bit difficult, but can be done. Image 5a shows a problem with the rubber seal. Notice the blue color extending further out from the left door. Image 5b is a freezer aisle shot showing a failed heating element on door three.

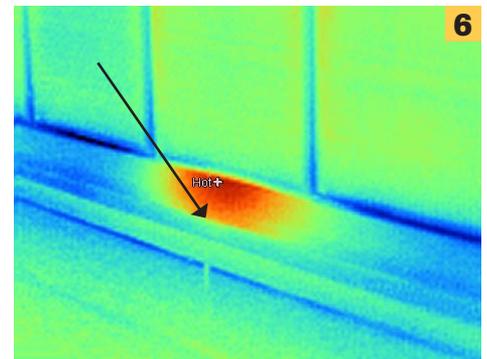
Lighting ballasts are another issue on the freezer aisle. Just like other ballasts, freezer lighting failure can often be predicted based on temperature fail points. Image 6 shows a warm ballast; Not yet to a point of failure, but warmer than others in the same aisle. At the beginning of a customer’s thermography program, it would be nearly impossible to predict a failure without baseline and historical data.
